Welding Horn Failures

Due to several complains about catastrophic welding horn failures within only little days of production, Spühl GmbH examined together with SwissSonic failed parts and examined the reasons for failing. From these experiences, the following “lessons learned” points were derived:

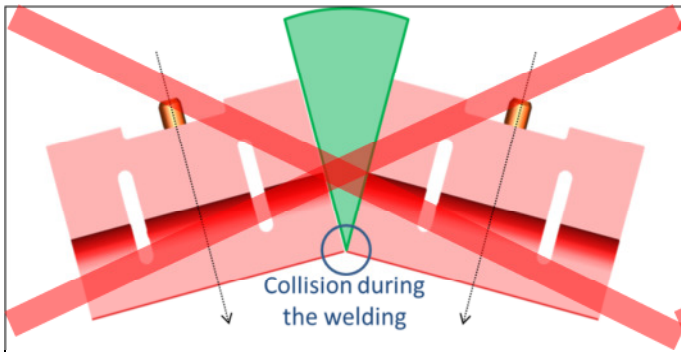
<p>Collision during the welding</p>

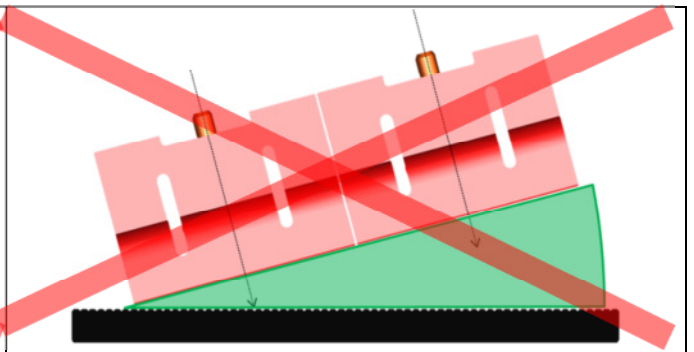
<p>WELDING HORNS HAVE TO BE PARALLEL</p>	<p>WELDING SURFACE HAS TO BE PARALLEL TO ANVIL</p>

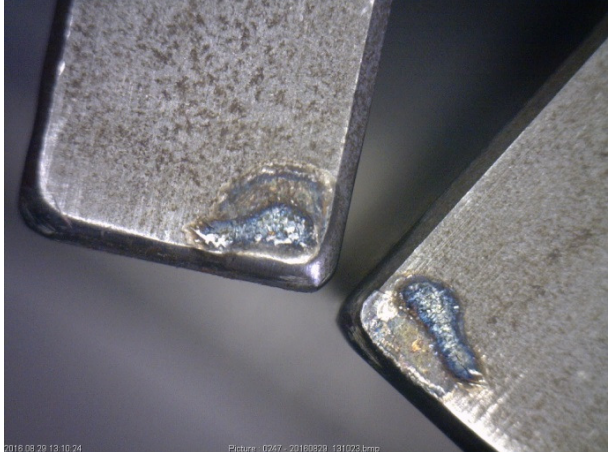
Mode of failure (description)	Mode of failure (picture)
<p>Corners of the welding surface get too hot → discoloration and crack starting.</p> <p>Error from the booster and the control because no proper resonance vibration can be reached.</p> <p>Corners would start break pretty soon.</p>

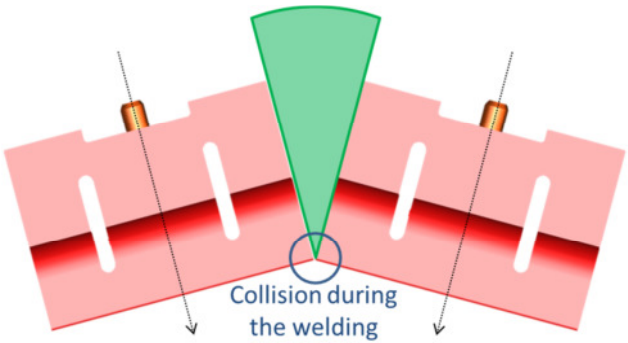
Most probably cause of failure (description)	Most probably cause of failure (graphics)
<p>Instead of the two welding horns being installed parallel, there is an angle between the two horns.</p> <p>Even though they don't touch when they are not vibrating, with a positive amplitude of around 0.02 mm the gap might be too small, so there is contact between the two horns.</p>

How to prevent (description)	How to prevent (graphics)
<p>Welding horns have to be installed 100% parallel to each other.</p> <p>Align welding horns / sonotrodes according the manual written by Spühl (Chapter 8.14.6 – newest version)</p> <p>Therefore use the special equipment from Spühl (part no 33.33588.40 (new version) for P-450)</p> <p>Procedure is explained in detail in chapter “8.14 Transverse welding equipment” in the Spühl manual for P-450</p>

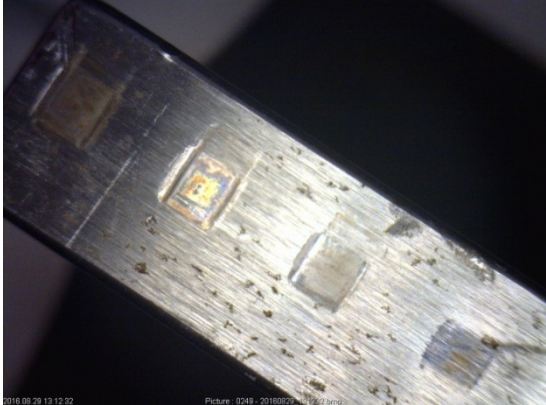
Mode of failure (description)	Mode of failure (picture)
<p>There are grooves caused by the anvil → the grooves are not over the whole width visible. On one side there are only small marks – on the other are deeper grooves</p>

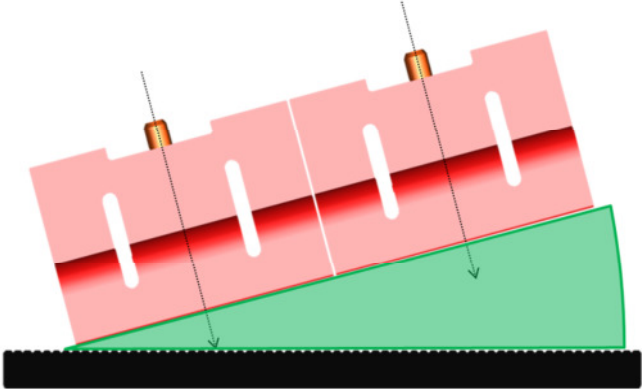
Most probably cause of failure (description)	Most probably cause of failure (graphics)
<p>The anvil and the welding horns are not perfectly aligned in a parallel way. There is an angle between the welding surface and the anvil surface</p>

How to prevent (description)	How to prevent (graphics)
<p>Align welding horns / sonotrodes according the manual written by Spühl (Chapter 8.14.6 – newest version)</p> <p>Therefore use the special equipment from Spühl (part no 33.33588.40 (new version) for P-450)</p> <p>Procedure is explained in detail in chapter “8.14 Transverse welding equipment” in the Spühl manual for P-450</p>

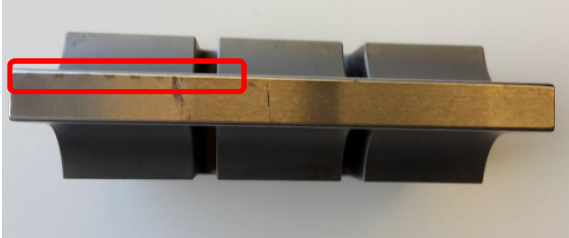
Mode of failure (description)	Mode of failure (picture)
<p>The welding horn is not aligned in the center towards the anvil. The anvil is off center and has only contact at the edge.</p>

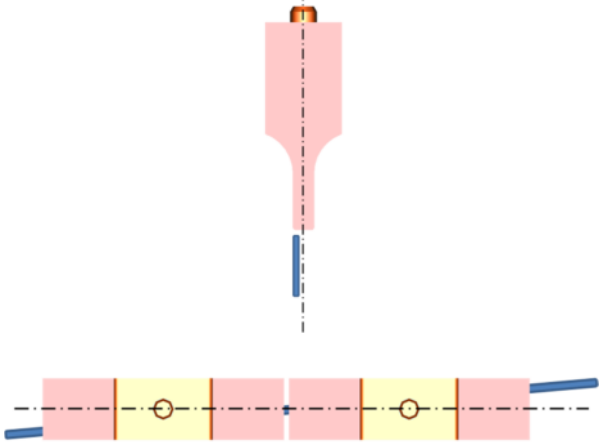
Most probably cause of failure (description)	Most probably cause of failure (graphics)
<p>Two possible errors can occur regarding the center line of the anvil.</p> <p>When the anvil is off center – there is an additional bending moment on the holding fixture and the welding horn at the screw position. When there is an additional angle between the center line of the anvil and the center line of the welding surface, the contact area is getting smaller and smaller. Therefore the contact stress is getting higher and higher.</p> <p>The result is a bad welding (if there is welding at all) and a failure of the welding horn after a short period of production</p>

<p>The relative alignment between welding horn and anvil has to be checked in the machine after assembling all parts!</p> <p>The anvil has to be in the center of the welding surface when the device is closed!</p>

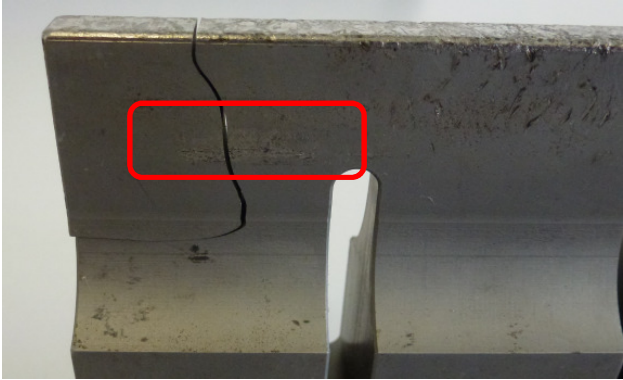
Mode of failure (description)	Mode of failure (picture)
<p>Edge of the welding horn is braking off</p> <p>Scratches from contact to other tools on the side of the welding horn.</p>

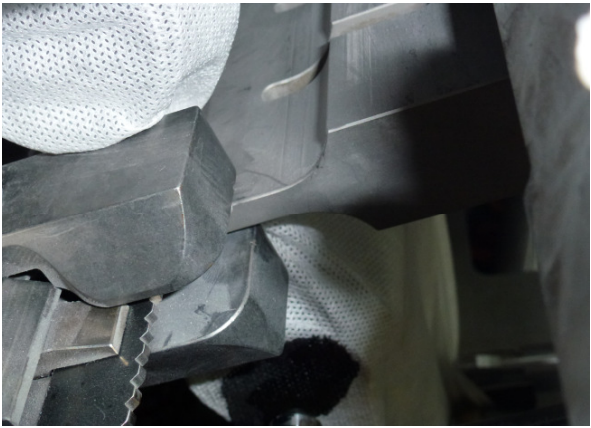
Most probably cause of failure (description)	Most probably cause of failure (graphics)
<p>There is contact between other machine parts and the welding horn.</p> <p>A sidewise contact between welding horn and machine parts are causing a catastrophic failure in a short period of time!</p>

How to prevent (description)	How to prevent (graphics)
<p>Control the gap between machine parts (especially the tools to prevent "pig ears")</p> <p>The gap should be on both sides of the welding horn the same (with the current tools at least 1mm or more)</p>

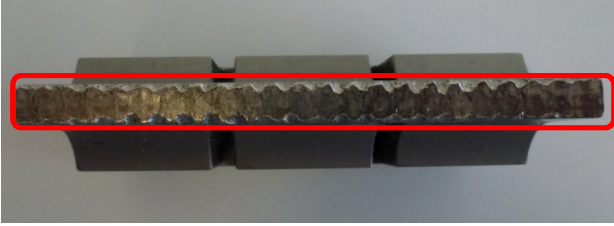
Mode of failure (description)	Mode of failure (picture)
<p>Surface of the welding horn has deep grooves on both edges – the distance is regular between each notch</p>

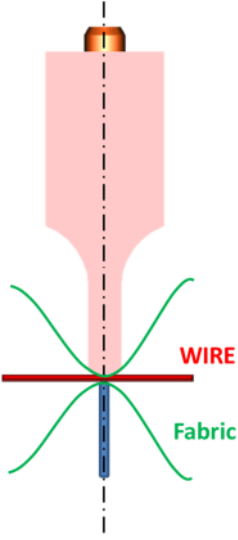
Most probably cause of failure (description)	Most probably cause of failure (graphics)
<p>Spring is not positioned correctly – the wire is between the anvil and the welding horn...</p> <p>The anvil and the welding horn are pushed together with a high force – and the anvil starts vibrating. Due to the high Hertzian stress, the welding horn starts getting grooves.</p> <p>Over a long period of production – the regular pattern occurs caused by the probability of the position of the wire between anvil and welding horn...</p>

How to prevent (description)	How to prevent (graphics)
<p>Try to prevent having a wire between anvil and welding horn by checking:</p> <p>fabric channel – and fabric guidance spring transport – and spring releasing into fabric channel</p>	<p>How to prevent (graphics)</p>

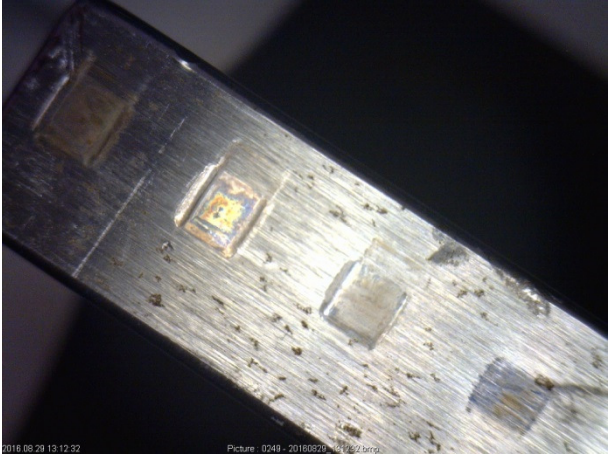
Mode of failure (description)	Mode of failure (picture)
<p>There are grooves cause by the anvil – but the grooves are not over the whole width of the welding surface the same</p> <p>Most of the times, the grooves start usually where the fabric ends.</p>

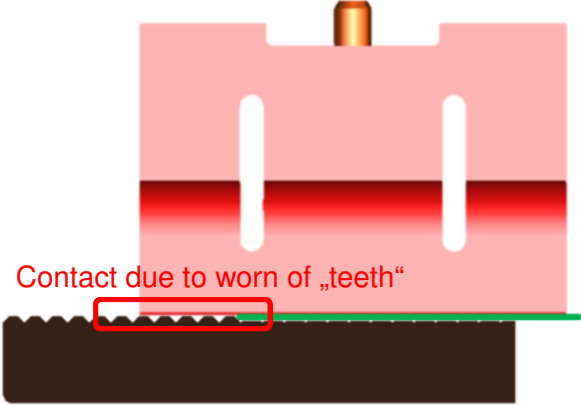
Most probably cause of failure (description)	Most probably cause of failure (graphics)
<p>The anvil is worn out in a way, that in the middle position, the “teeth” are lower than at the end.</p> <p>This can result in a direct contact between anvil and welding horn, because the distance given by the fabric cannot prevent a direct contact.</p> <p>Direct contact between welding horn and anvil causes a huge stress which will cause a failure in a short amount of time!</p>

<p>Contact due to worn of „teeth“</p>
How to prevent (description)	How to prevent (graphics)
<p>The anvil is the wear part of the whole system!</p> <p>It is highly recommended to change the anvil and assembly a new one each time the welding horn has to be replaced!</p> <p>A regular check of the wear of all teeth on the anvil is recommended each time a new fabric role is inserted!</p>
