Welding Horn Failures

Due to several complains about catastrophic welding horn failures within only little days of production, Spühl GmbH examined together with SwissSonic failed parts and examined the reasons for failing. From these experiences, the following “lessons learned” points were derived:

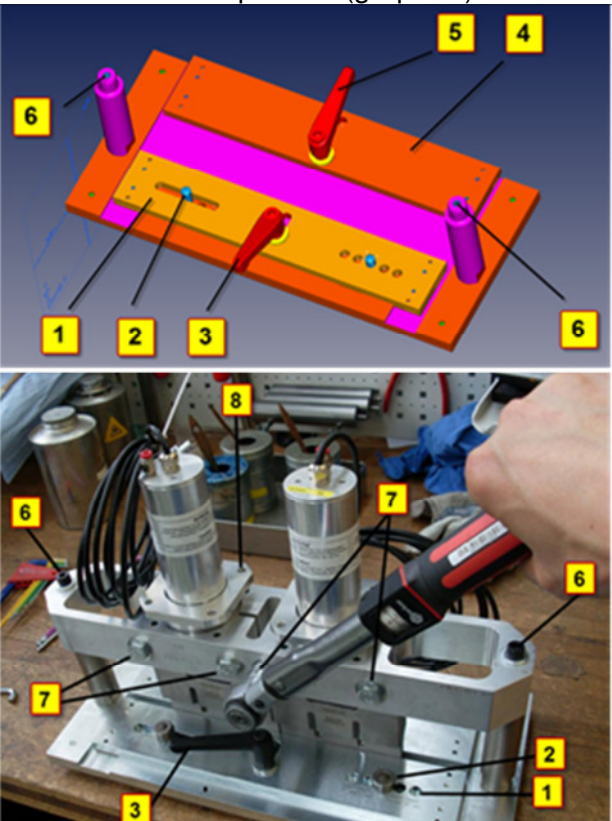
Mode of failure (description)	Mode of failure (picture)
<p>Corners of the welding surface get too hot → discoloration and crack starting.</p> <p>Error from the booster and the control because no proper resonance vibration can be reached.</p> <p>Corners would start break pretty soon.</p>

Most probably cause of failure (description)	Most probably cause of failure (graphics)
<p>Instead of the two welding horns being installed parallel, there is an angle between the two horns.</p> <p>Even though they don't touch when they are not vibrating, with a positive amplitude of around 0.02 mm the gap might be too small, so there is contact between the two horns.</p>

How to prevent (description)	How to prevent (graphics)
<p>Welding horns have to be installed 100% parallel to each other.</p> <p>Align welding horns / sonotrodes according the manual written by Spühl (Chapter 8.14.6 – newest version)</p> <p>Therefore use the special equipment from Spühl (part no 33.33588.40 (new version) for P-450)</p> <p>Procedure is explained in detail in chapter “8.14 Transverse welding equipment” in the Spühl manual for P-450</p>

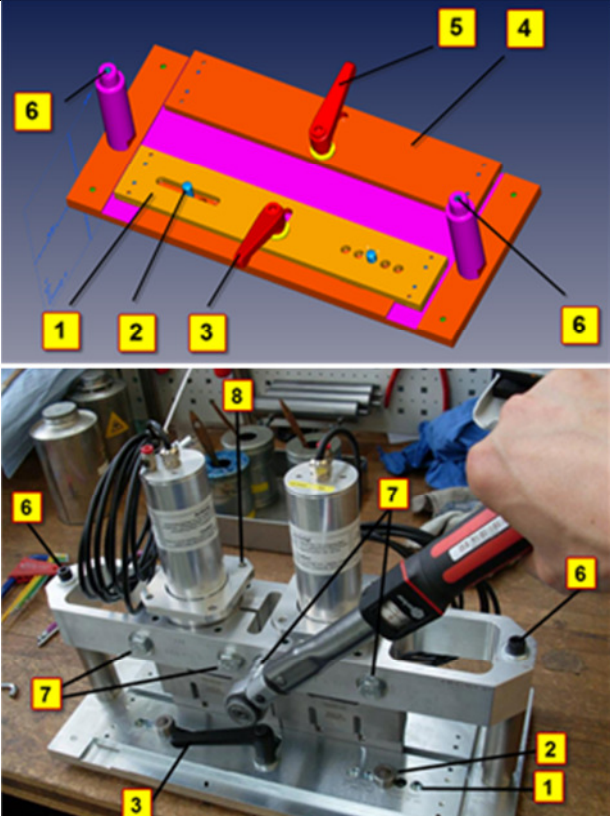
Mode of failure (description)	Mode of failure (picture)
<p>There are grooves caused by the anvil → the grooves are not over the whole width visible. On one side there are only small marks – on the other are deeper grooves</p>

Most probably cause of failure (description)	Most probably cause of failure (graphics)
<p>The anvil and the welding horns are not perfectly aligned in a parallel way. There is an angle between the welding surface and the anvil surface</p>

How to prevent (description)	How to prevent (graphics)
<p>Align welding horns / sonotrodes according the manual written by Spühl (Chapter 8.14.6 – newest version)</p> <p>Therefore use the special equipment from Spühl (part no 33.33588.40 (new version) for P-450)</p> <p>Procedure is explained in detail in chapter “8.14 Transverse welding equipment” in the Spühl manual for P-450</p>

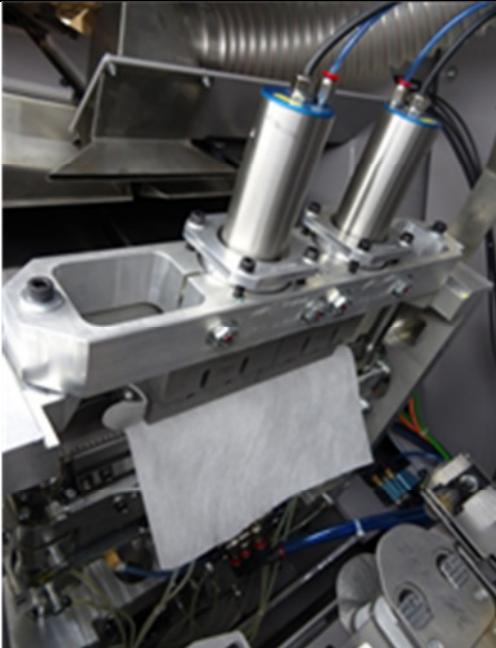
Mode of failure (description)	Mode of failure (picture)
<p>The welding horn is not aligned in the center towards the anvil. The anvil is off center and has only contact at the edge.</p>

Most probably cause of failure (description)	Most probably cause of failure (graphics)
<p>Two possible errors can occur regarding the center line of the anvil.</p> <p>When the anvil is off center – there is an additional bending moment on the holding fixture and the welding horn at the screw position. When there is an additional angle between the center line of the anvil and the center line of the welding surface, the contact area is getting smaller and smaller. Therefore the contact stress is getting higher and higher.</p> <p>The result is a bad welding (if there is welding at all) and a failure of the welding horn after a short period of production</p>

<p>The relative alignment between welding horn and anvil has to be checked in the machine after assembling all parts!</p> <p>The anvil has to be in the center of the welding surface when the device is closed!</p>

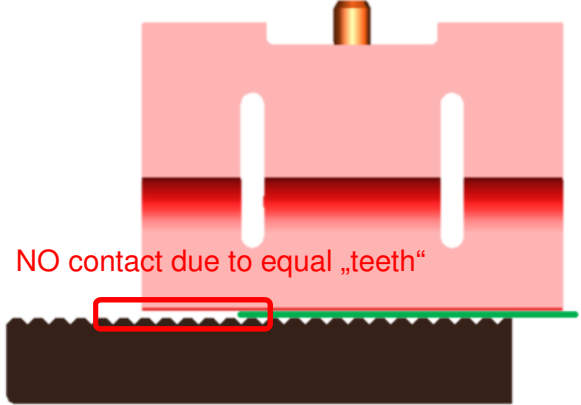
<p>NO contact due to equal „teeth“</p>

Mode of failure (description)	Mode of failure (picture)
<p>There are grooves cause by the anvil – but the grooves are not over the whole width of the welding surface the same</p> <p>Most of the times, the grooves start usually where the fabric ends.</p>

Most probably cause of failure (description)	Most probably cause of failure (graphics)
<p>The anvil is worn out in a way, that in the middle position, the “teeth” are lower than at the end.</p> <p>This can result in a direct contact between anvil and welding horn, because the distance given by the fabric cannot prevent a direct contact.</p> <p>Direct contact between welding horn and anvil causes a huge stress which will cause a failure in a short amount of time!</p>

<p>Contact due to worn of „teeth“</p>
How to prevent (description)	How to prevent (graphics)
<p>The anvil is the wear part of the whole system!</p> <p>It is highly recommended to change the anvil and assembly a new one each time the welding horn has to be replaced!</p> <p>A regular check of the wear of all teeth on the anvil is recommended each time a new fabric role is inserted!</p>
